LAYING AND REPAIRING A SIX-INCH WROUGHT IRON SUBMARINE PIPE LINE AT PORTLAND, MAINE¹

BY JAMES W. GRAHAM²

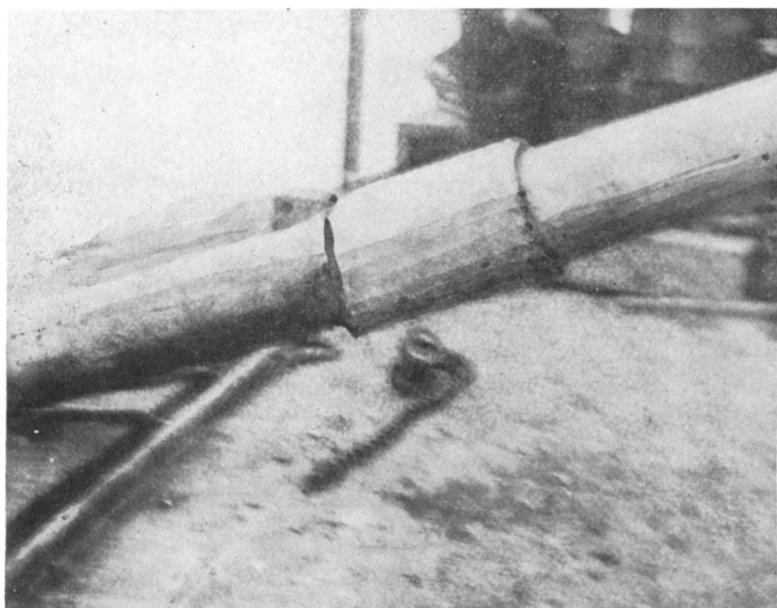
FIG. 4. THE SLEEVE IN PLACE

When the scow finally approached the Island shore the pipe was laid in the regular way at high tide to a point well above low water. At low tide, men working on the flats connected up additional pipe. When the pipe end was lowered into the water it was carefully plugged in order that no water might get inside. The work was carried on the same way between Little Diamond and Peaks Island. The distance was 2500 feet and the water was comparatively shallow. The wrought iron pipe was carried up to a point near half tide where

it was connected to cast iron pipe by a cast iron sleeve. That part of the line crossing Little Diamond Island and on Peaks Island and Portland necessary to connect with existing mains was laid with cast iron pipe. The line crossing Little Diamond Island, about 1500 feet in length, was laid on the surface of the ground and the joints were made of Lead-Hydro-Tite. It took two days for our men to learn to handle this compound, and then the work proceeded smoothly. It became evident that a gasoline burning furnace built

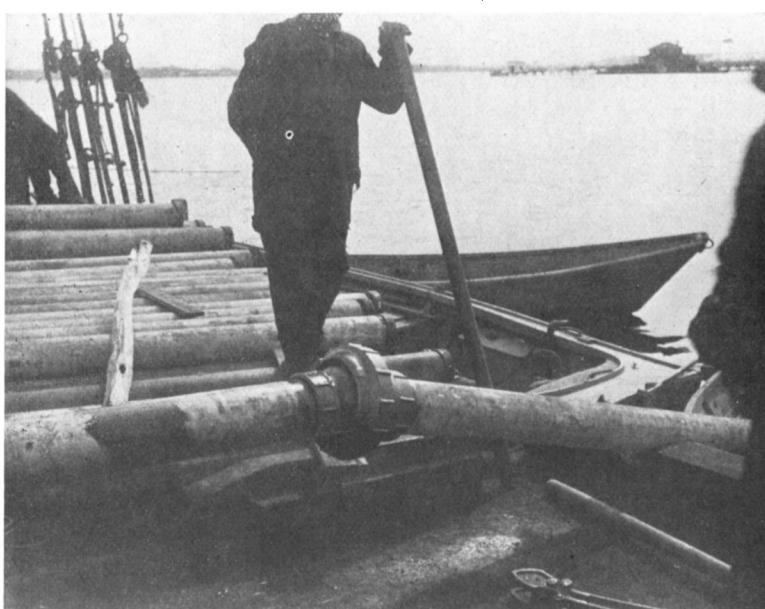
FIG. 7. A MORAN JOINT

It was shown by examination of the pipe that broke off in attempting to raise it that the pipe would bend a little before the joint would fail and it seemed that if the joint was a little stronger it would be possible to raise and lower the pipe as often as desired.

We accordingly designed and tested a method of strengthening the joints. A piece of 8-inch galvanized wrought iron pipe was cut off to a length of 13 inches. This was placed over the coupling between two pieces of 6-inch wrought iron pipe and held in place by small wooden wedges. The space between the 6-inch pipe and coupling and the 8-inch sleeve was then filled with Leadite. The Leadite cooled in 2 or 3 minutes so that the collars and clay could be removed. We then suspended the section of pipe at its two ends and piled pigs of lead on a platform suspended at the center by a rope on each side of the joint. It required 3800 pounds of lead to exceed the elastic limit of the pipe metal and put a permanent bend in the pipe.

The laying of pipe was immediately begun, each coupling being covered with an 8-inch sleeve and the space filled with Leadite. The tide was low and little wind blowing, and beginning at the middle of the deep channel and moving toward Little Diamond Island, we laid 200 feet of pipe and lowered it to the bottom before dark with a plug screwed into the end. The following day at low tide the end was easily raised from the bottom as all the joints were then reinforced. The laying of pipe was continued.
